Rapid Response to Transformer Explosion at Power Plant

AZZ designed, built, shipped, installed, and commissioned replacement SF₆ gas insulated line (GIL) in just 39 days

High Voltage Bus Systems Case Study

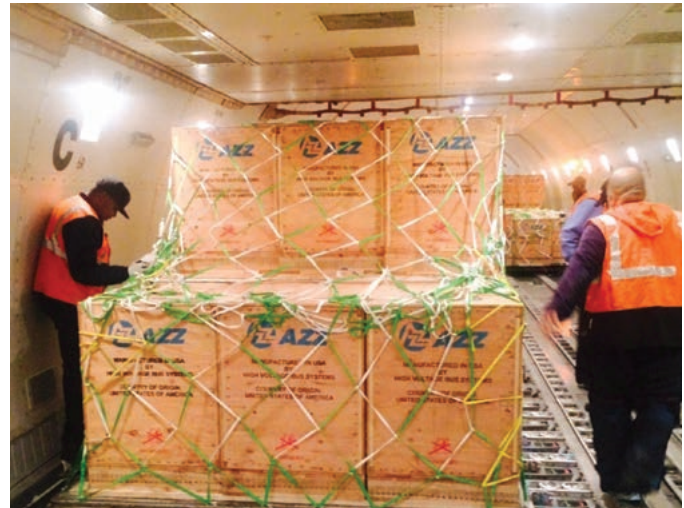
Loading of equipment onto chartered plane at JFK

In total, 22 tons of AZZ high voltage transmission equipment were air freighted to Saudi Arabia via 747, a 48-hour transit from origin to destination that normally requires 8 weeks.

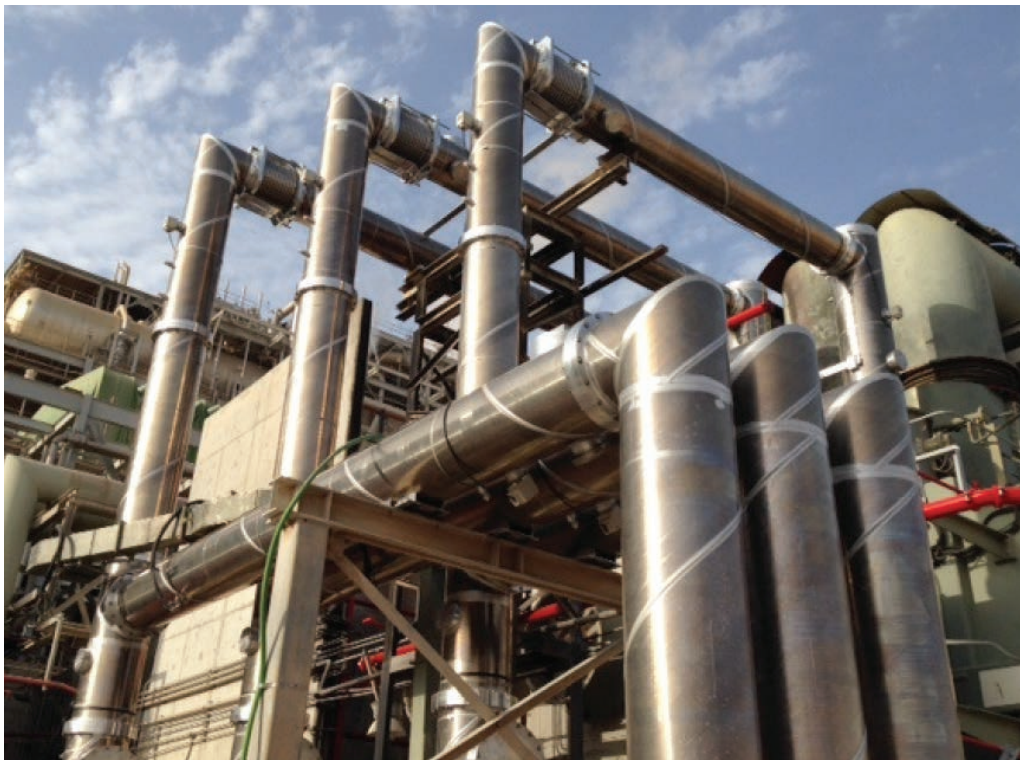
Replacement transformer with new AZZ GIL ready for energization

Due to the severity of the transformer fault and collateral damage, this repair required a total of 36 sections to bring the generator back online, which required expedited manufacturing of additional standard components, including flanges, silver plated contact assemblies, adjustment bellows and epoxy insulators. AZZ maintains an emergency supply of standard GIL components as well as an in-house capability to produce additional components and thus was able to rapidly produce the needed components within days of understanding the full required scope of supply.

After seven days of around-the-clock installation coordinated by AZZ, the equipment was ready for high voltage testing and commissioning, which were completed in less than one week. The plant was brought back on line three full days before the start of Ramadan as strongly desired by the utility due to mid-summer being the time of peak demand.
